Central Coast Regional Water Quality Control Board

ENFORCEMENT PROGRAM: SANTANA RANCH, SAN BENITO COUNTY – NOTICE OF VIOLATION AND REQUIRED REPORTING FOR FAILURE TO COMPLY WITH THE CONSTRUCTION STORMWATER GENERAL PERMIT, WQID NUMBERS 3 35C379415 AND 3 35C389797

Attachment 1 Santana Ranch

Attachment 2
Stormwater Runoff from
Santana Ranch Basin A to
Adjacent Properties

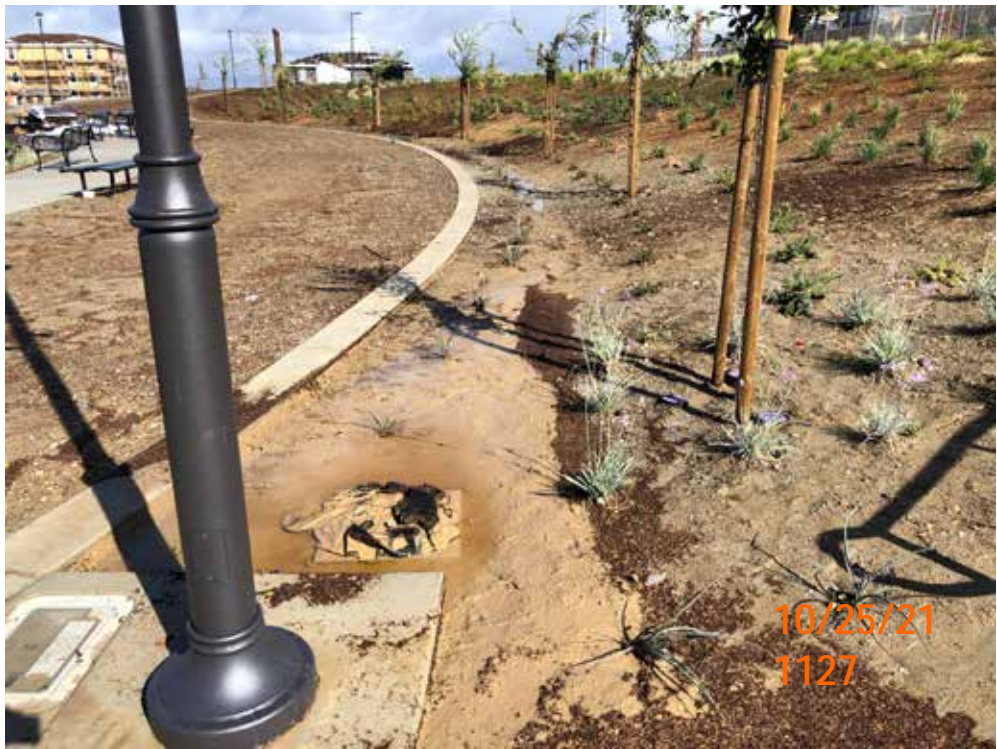
Photo 1. Community park area near toe of slope from Santana Ranch Rd. (right); note siltation and mulch, clogged drop inlet, and lack of erosion and sediment control BMPs.

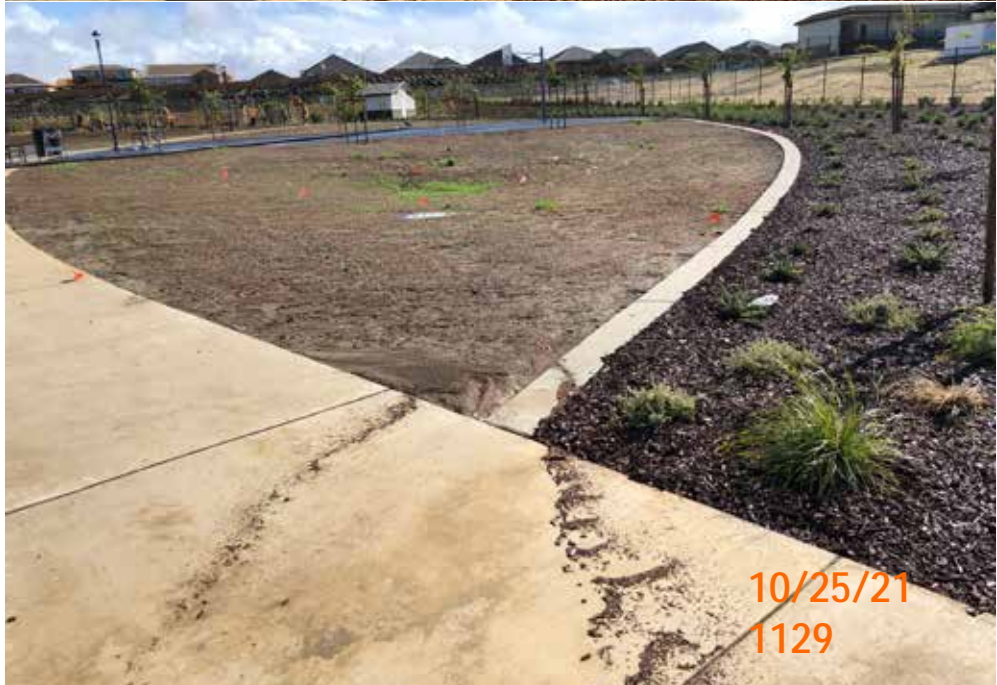
Photo 2. Community park area west of basketball court; note evidence of sheet flow across bare ground.

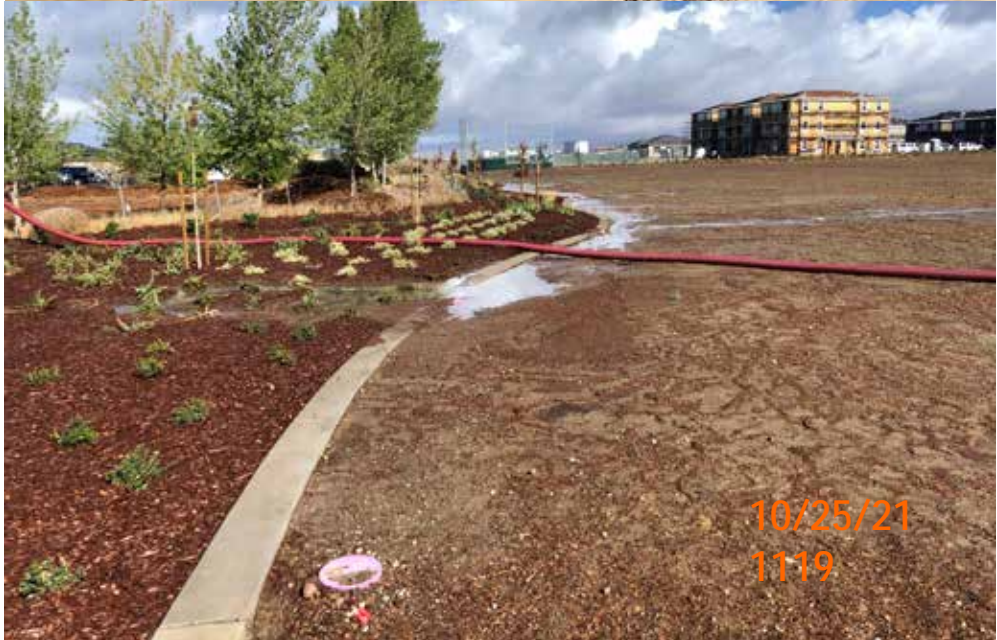
Photo 3. Community park boundary, Cal Fire to left; note sheet flow features across bare ground and concentrated flow occurring at edge strip. 4 to 6-inch hose in photo was used for pneumatic application of wood mulch.

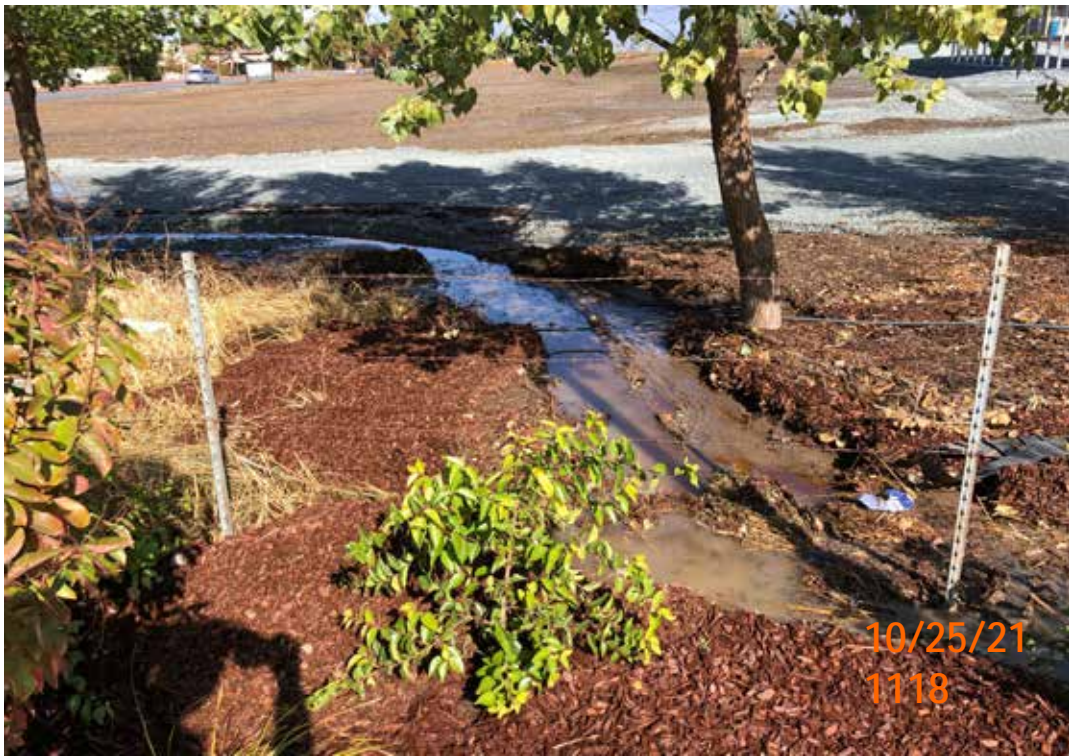
Photo 4.
Concentrated flow leaving park east from Photo 3.

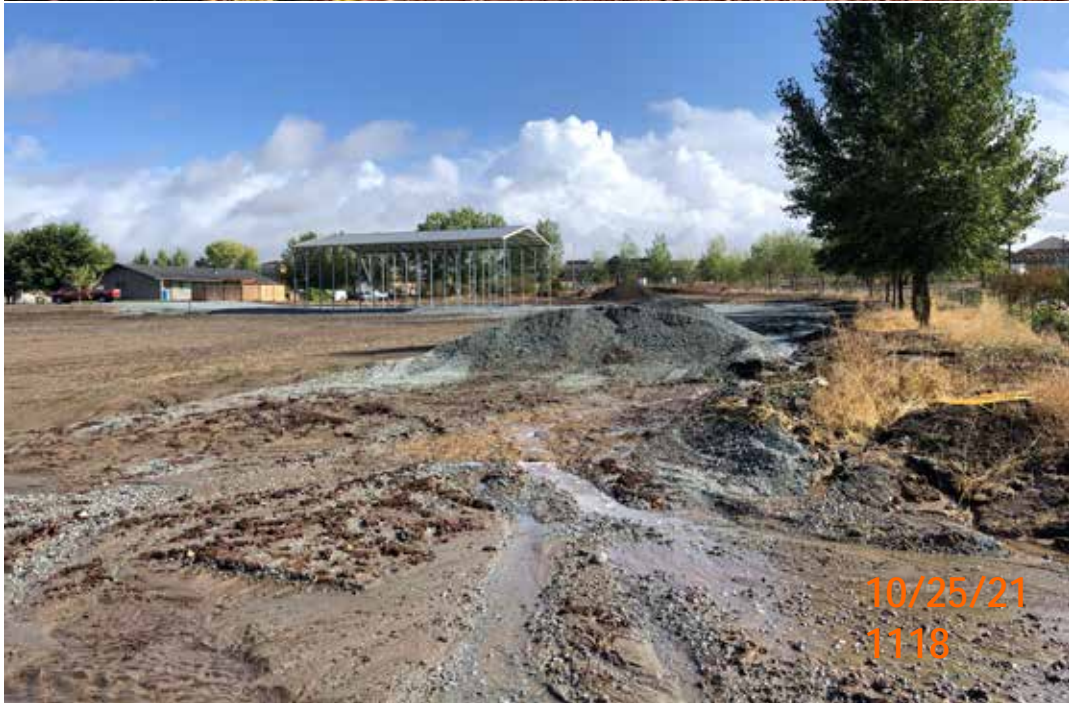
Photo 5. Look east from Fairview Rd., concentrated flow and anastomosing channels formed by discharge from community park and upland areas.

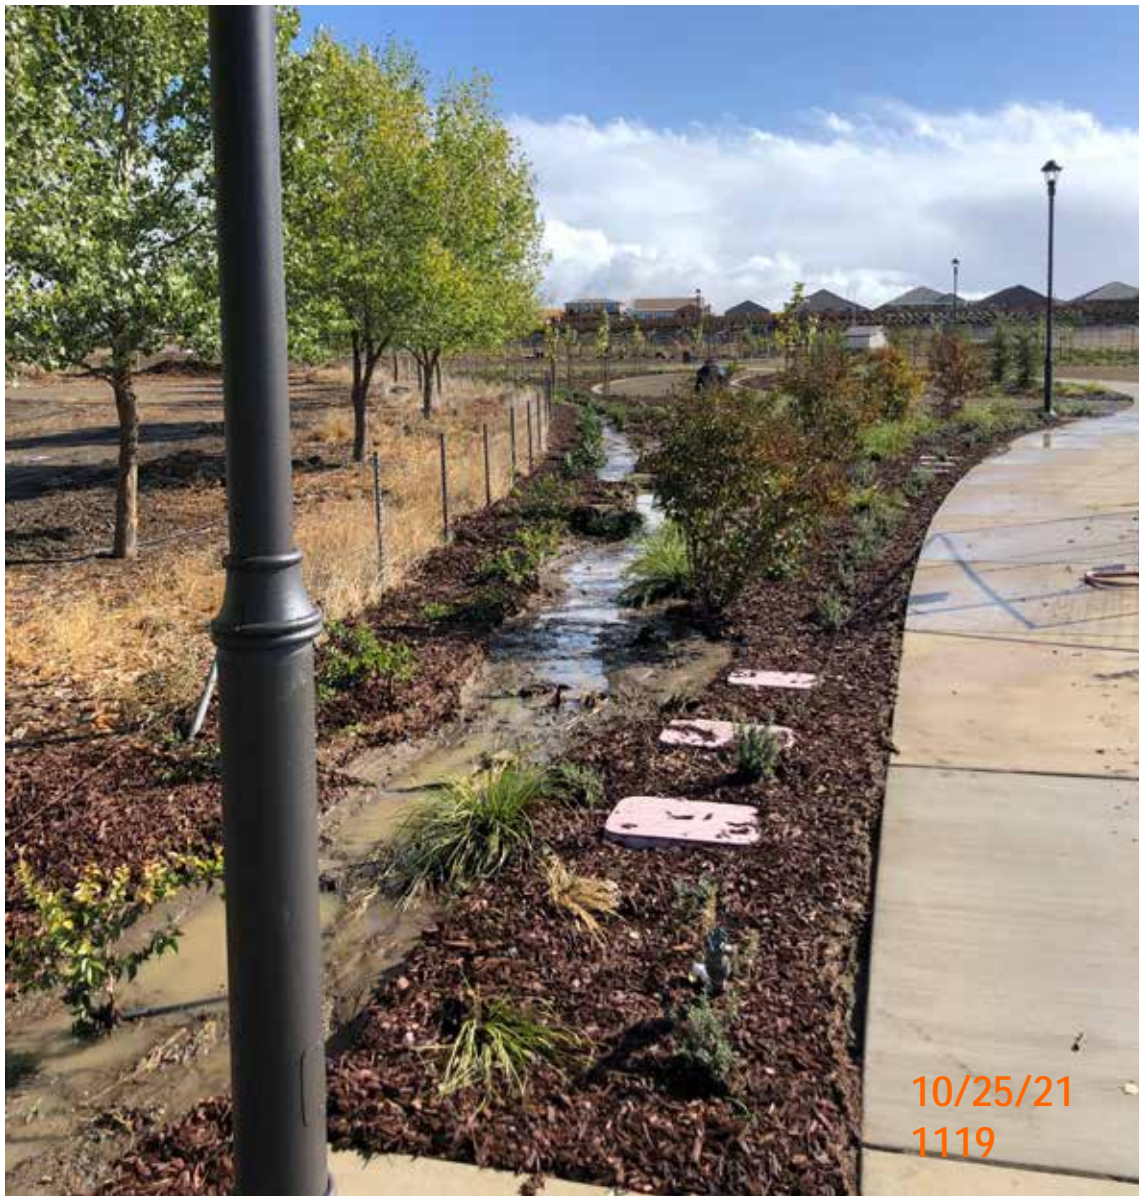
Photo 6. Looking east from Fairview Rd., south of Photo 5. Channelized flow from stormwater discharge from the community park and upland source areas.

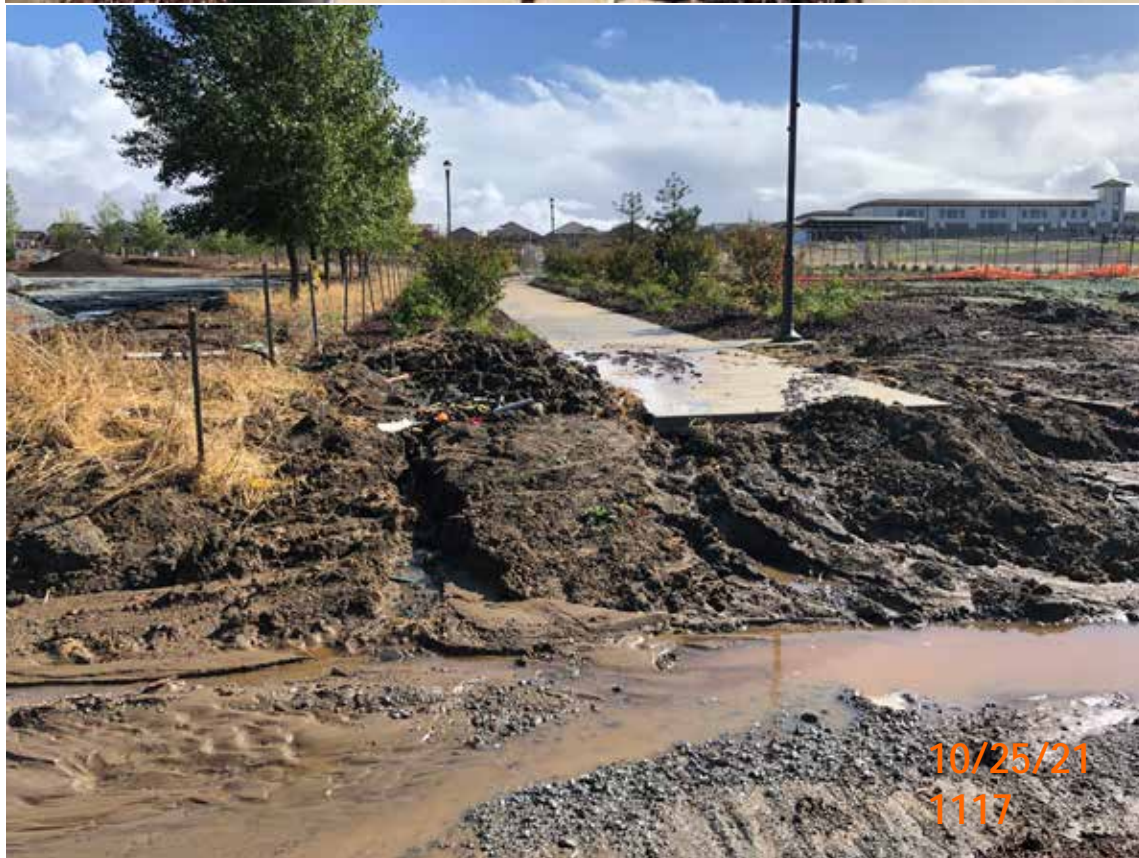
Photo 7. Looking east from edge of pavement on Fairview Rd., downstream of photo 6. Lack of erosion and sediment controls.

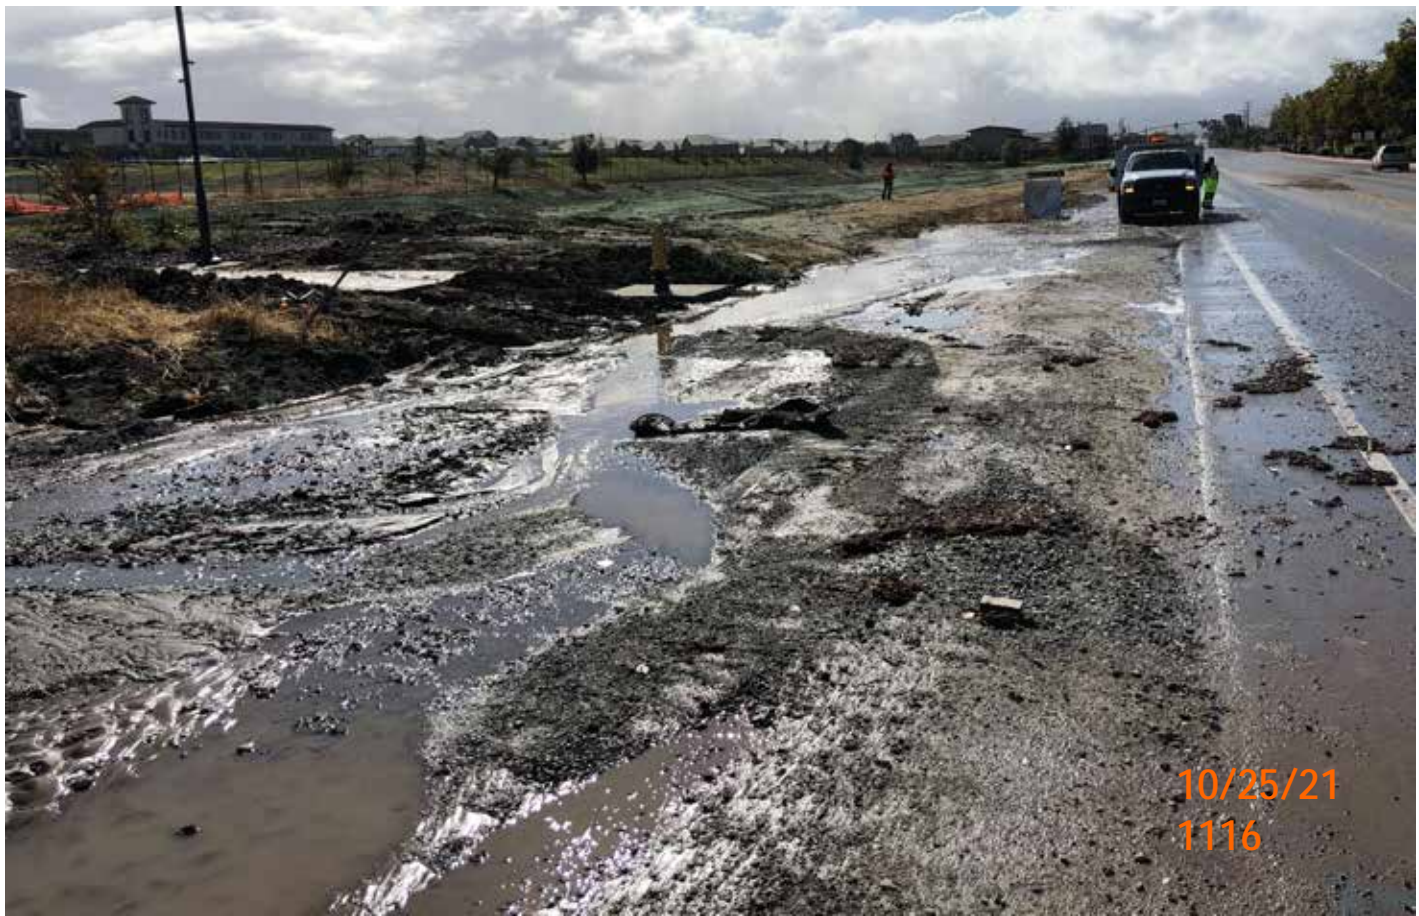
Photo 8. Looking south on Fairview Rd. near Photo 7 location.

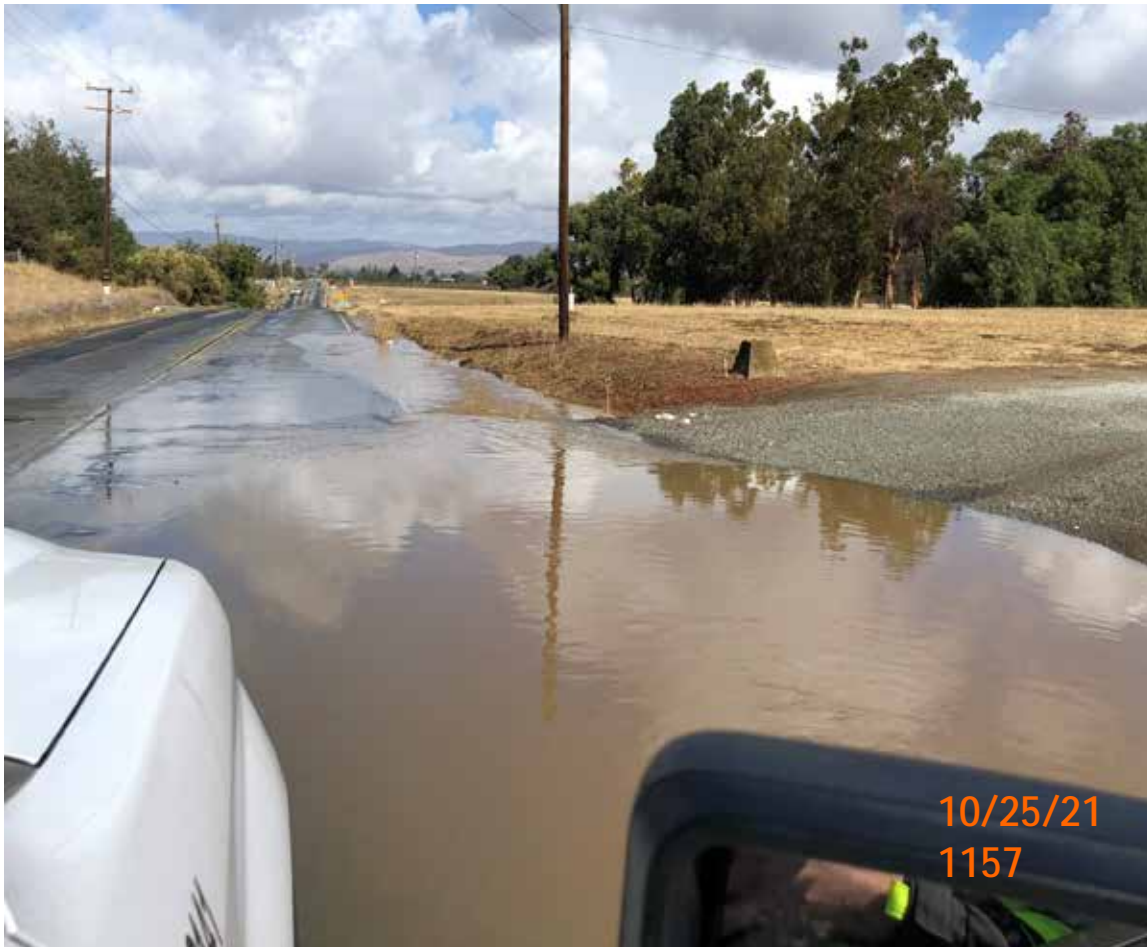
Photo 9. Looking north from edge of pavement on Fairview Rd., 1.1 miles north of the linear basin, half-way between Mansfield Rd (south) and Santa Ana Valley Rd (north). Turbid water discharge from Santana Ranch Basin A and construction site.

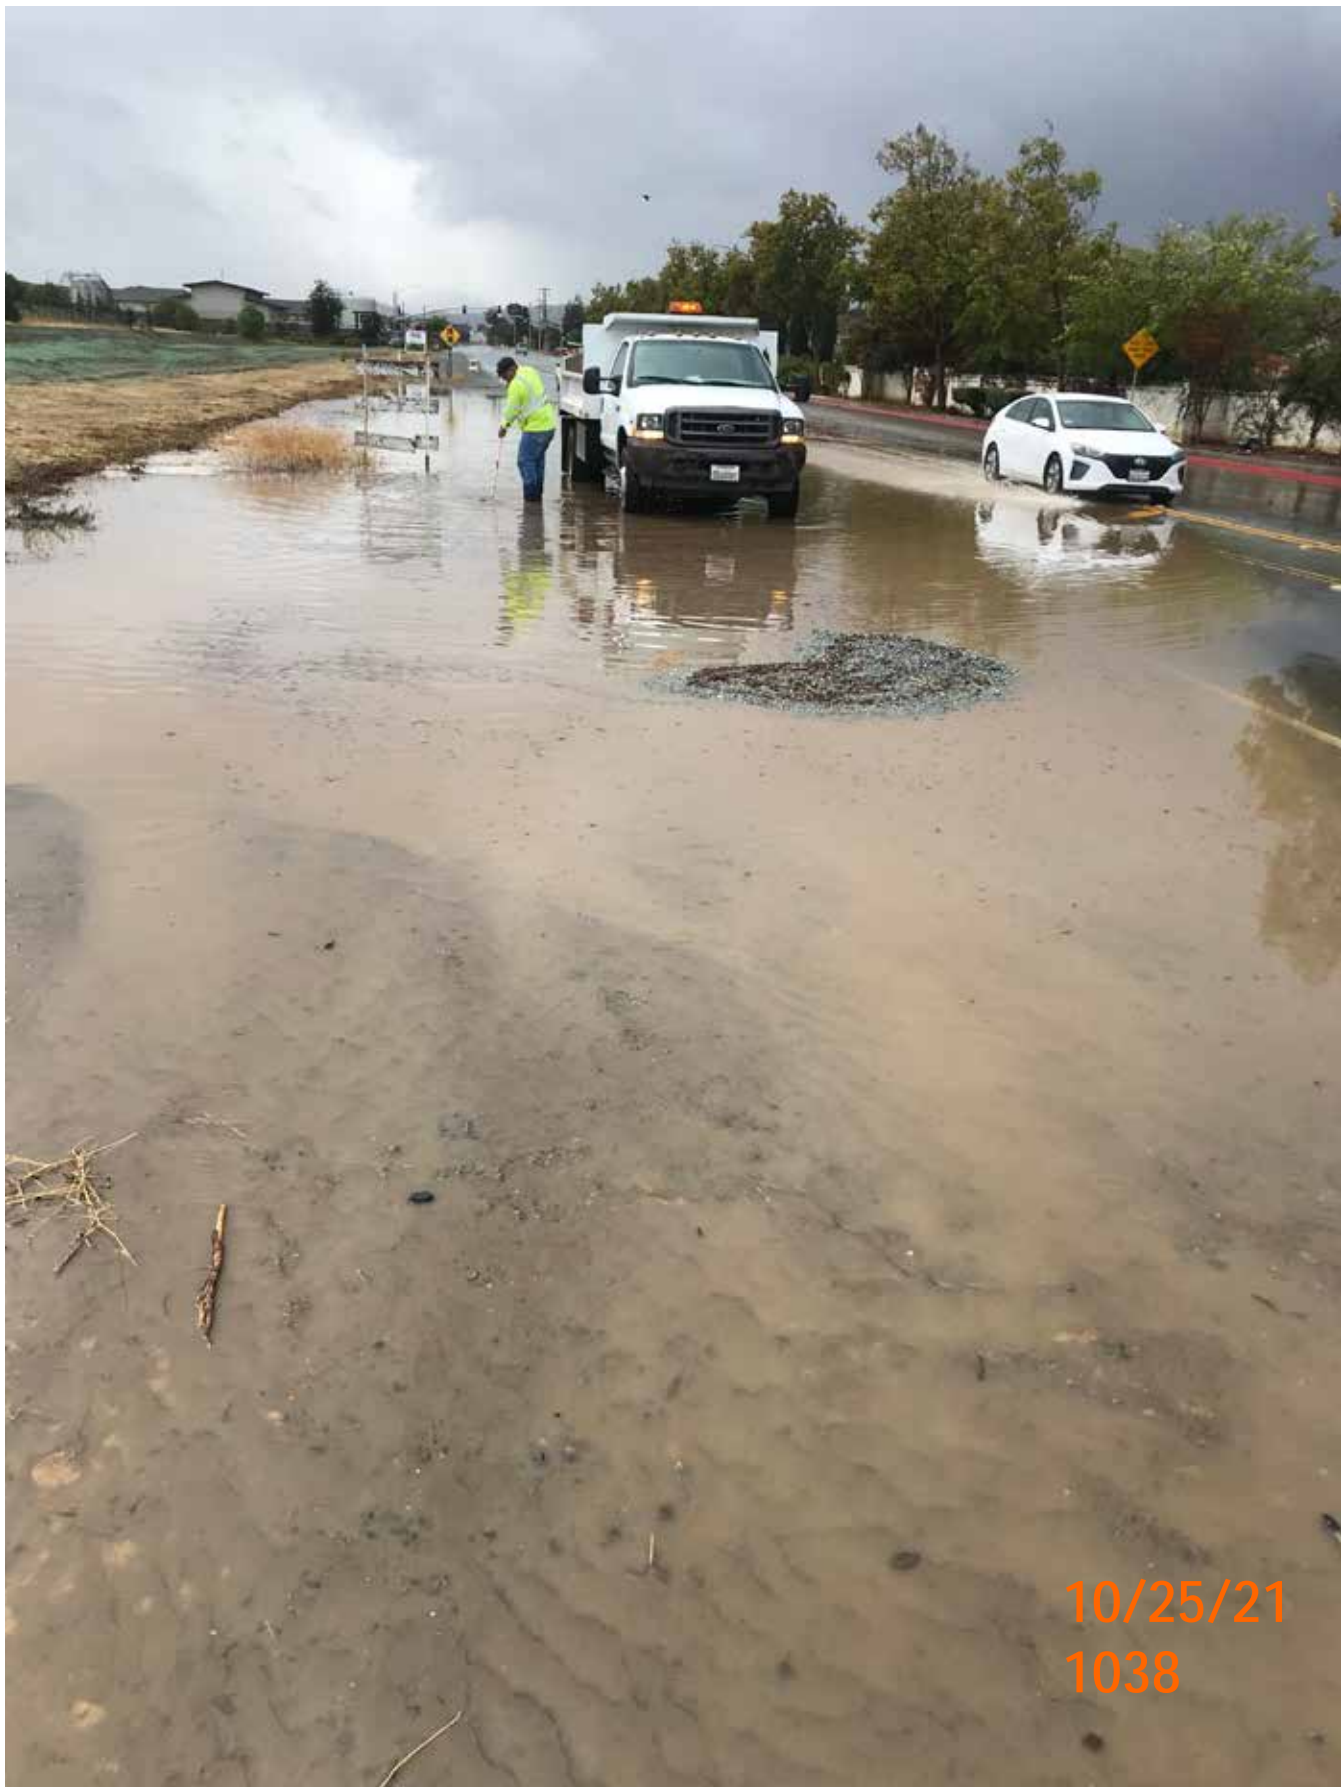
10/25/21
1038

Photo 10. Looking south from edge of pavement on Fairview Rd. Turbid water discharge from Santana Ranch construction site. Sediment in lower half of photo is soil surface east of edge of pavement. City attempting to find and clear storm drain feature.

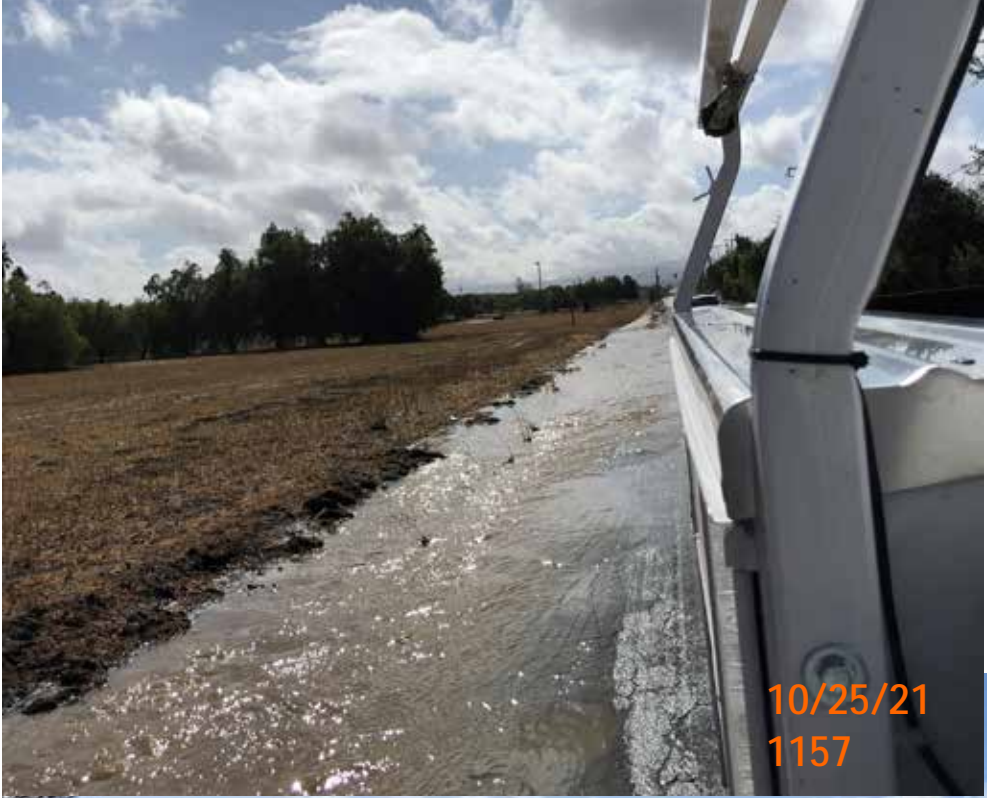
Photo 11. Looking south, edge of pavement on Fairview Rd. at location of Photo 9. Turbid water discharge from Santana Ranch Basin A and construction site.

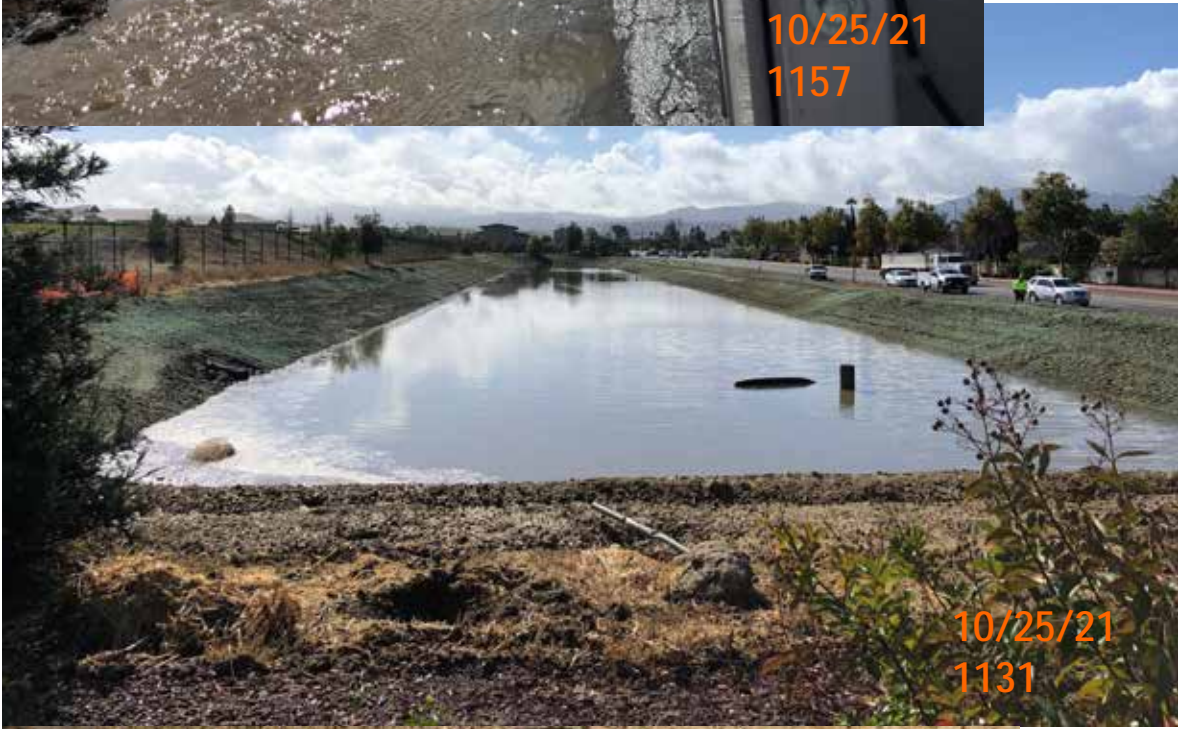
Photo 12. Looking south from north end of linear basin, Fairview Rd. to right.

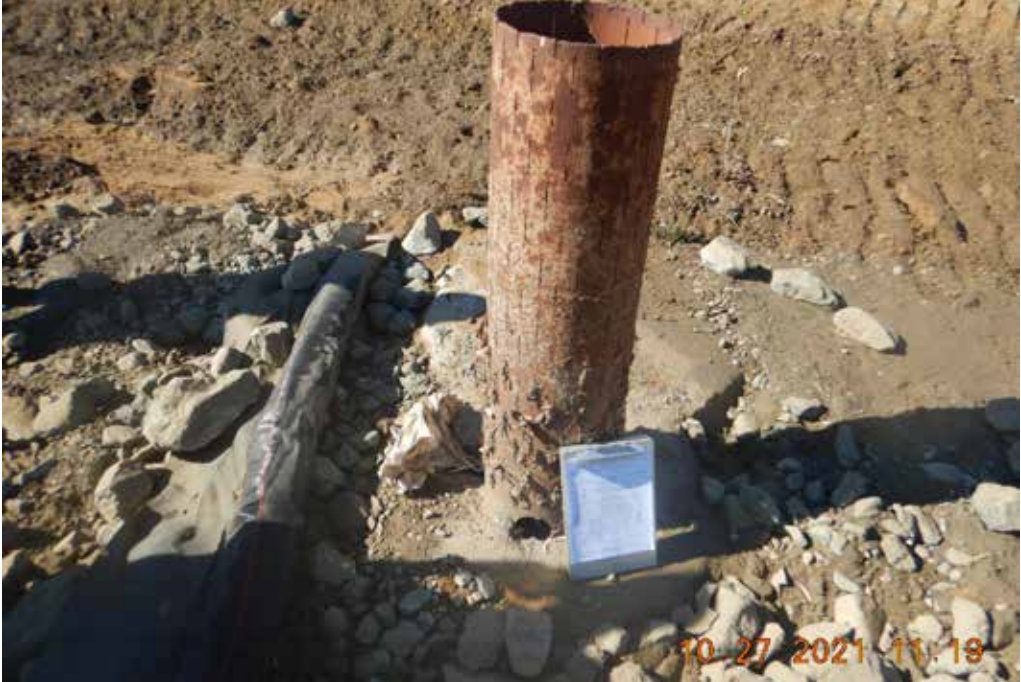
Photo 13. Standpipe in linear basin seen in Photo 12. 4.5 ft tall, 16-inch diameter reused slotted steel well casing. Note one of four 3-inch diameter holes cut at base of casing. Clipboard is 14x9 inches.

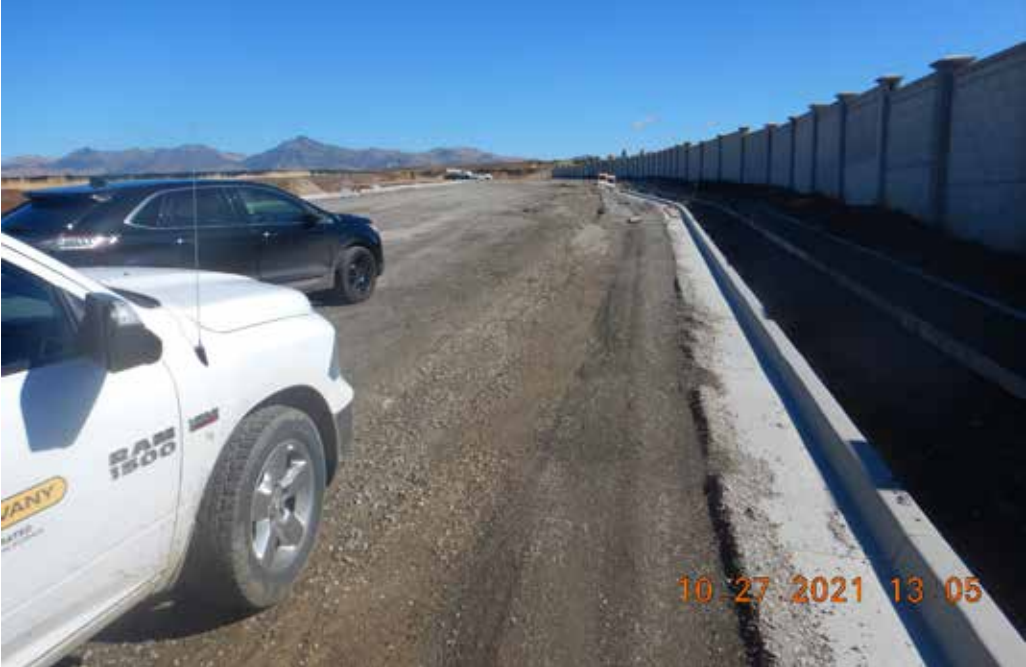
General Permit Attachment C section F requires the Dischargers to manage all run-on, all runoff within the site, and all runoff that discharges from the site. The aggregate base surface of Hillcrest Road displayed evidence of inadequately controlled sheet flow and concentrated flow, with erosion and transport of aggregate base to the ditch along Fairview Road. Inadequately controlled sheet flow from the community park and surrounding area developed into concentrated flow with runoff discharging wood mulch and sediment to Fairview Road (see Attachment 1 photos). These conditions demonstrate a lack of effective management of run-on and runoff. Failure to effectively manage run-on, runoff within the site, and runoff that discharges from the site are violations of General Permit Attachment C section F.

Photo 14. East extension of Hillcrest Rd. from Fairview Rd., showing evidence of concentrated flow in aggregate base along gutter. Note lack of erosion and sediment control BMPs. Central Coast Water Board staff inspection photo.

Action: The Dischargers must correct this violation as soon as possible. The violation can be corrected by implementing controls to effectively manage all run-on, all runoff within the site, and for all runoff that discharges off the site.

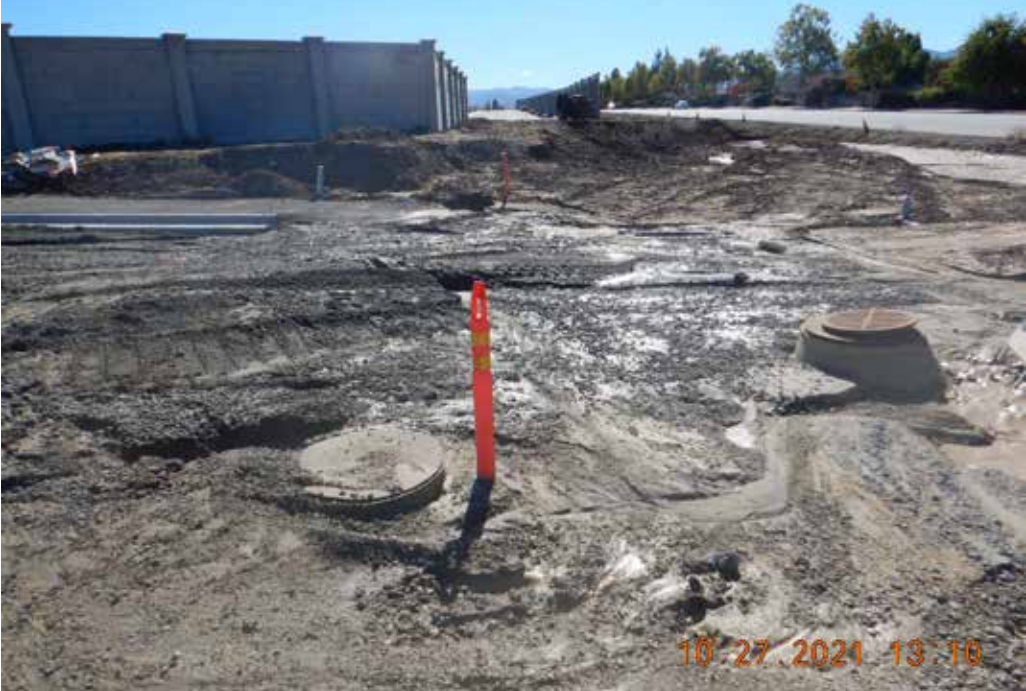
Photo 15. Hillcrest Rd. at Fairview Rd., showing sediment accumulation and sedimentary flow structures. Note lack of erosion and sediment control BMPs. Central Coast Water Board staff inspection photo.

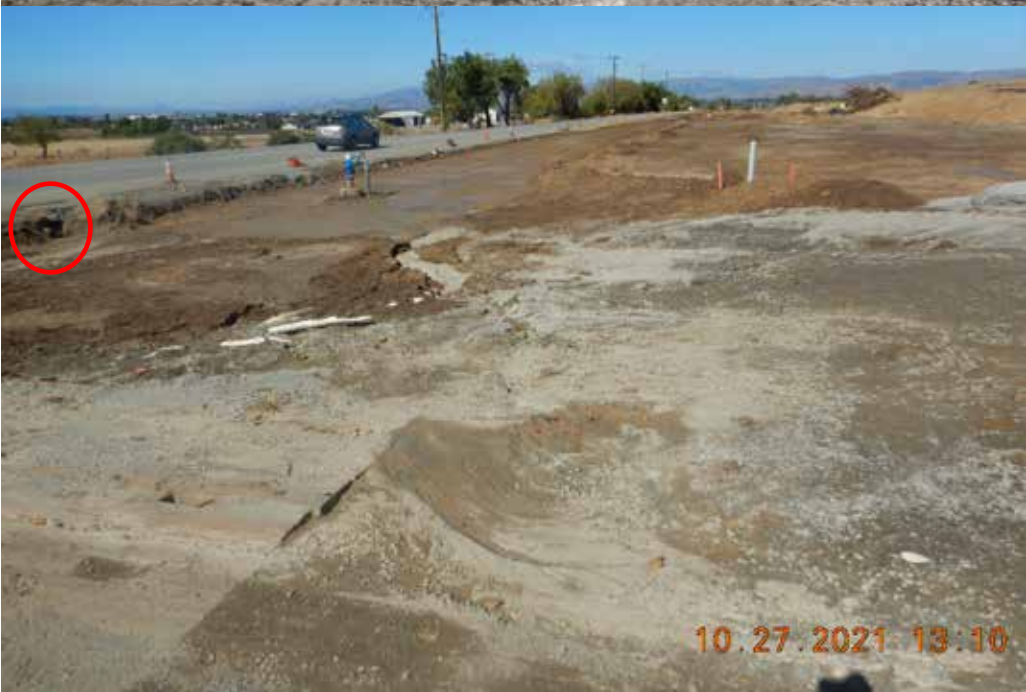
Photo 16. Hillcrest Rd. at Fairview Rd., showing sediment accumulation and sedimentary flow structures. Note lack of erosion and sediment control BMPs. Red circle is location of pipe under Fairview Rd. Central Coast Water Board staff inspection photo.

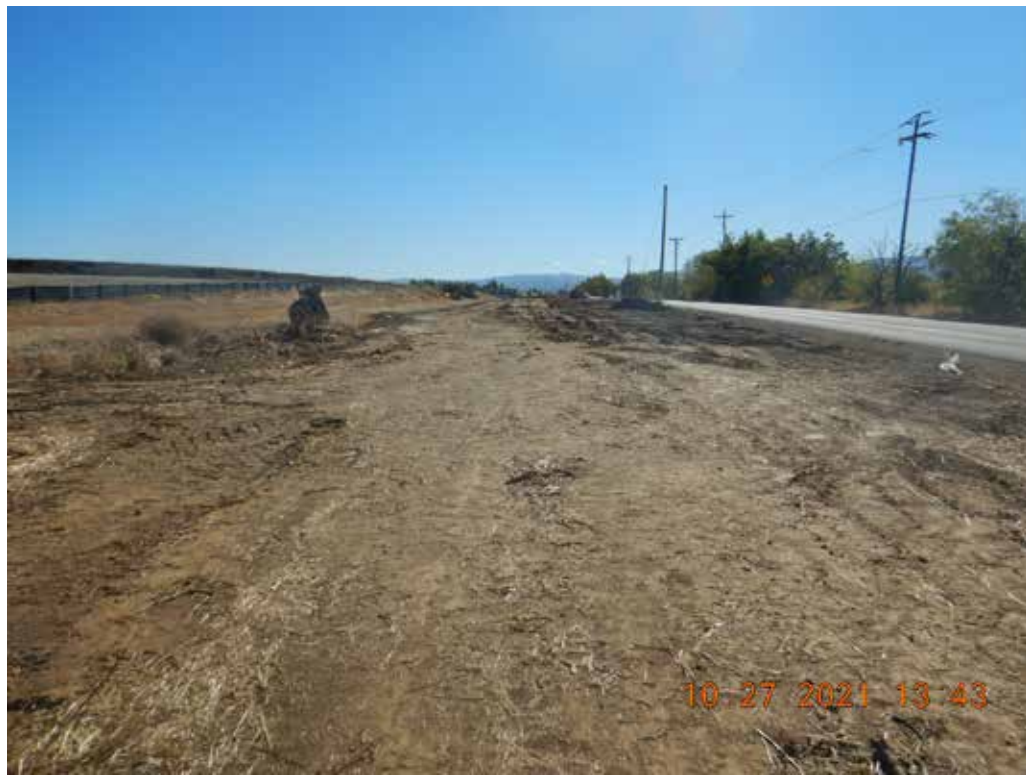
General Permit Attachment C section D.2 requires the Dischargers to provide effective soil cover for inactive areas and all finished slopes, open space, utility backfill, and open lots. While erosion and sediment control BMPs were observed on site, several acres of bare disturbed ground were observed along Fairview Road between the Cal Fire property and Basin B (about 2,100 linear feet by about 80 feet wide), in the new community park, on slopes along the Santana Ranch Road northerly extension, and in graded areas north and east of Santana Ranch Road extension (see Attachment 1, photos 16 - 18, and 4 - 8). Failure to provide effective soil cover for inactive areas and all finished slopes, open space, utility backfill, and open lots in these locations is a violation of General Permit Attachment C section D.2.

Photo 17. Cleared land east of Fairview Rd. Cleared land stretches from Cal Fire station (approx.) to Basin B, approximately 2,200 feet by about 80 feet wide. Note lack of erosion and sediment control BMPs. Central Coast Water Board staff inspection photo.

Action: The Dischargers must correct this violation as soon as possible. The violation can be corrected by implementing effective soil cover in required areas.

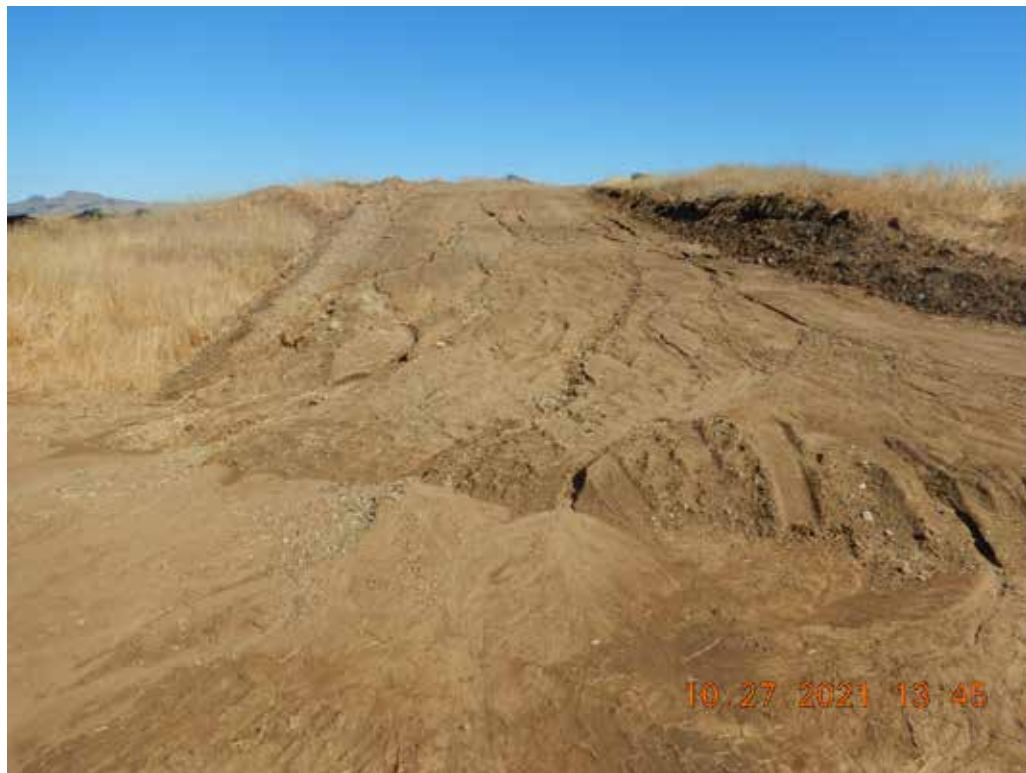
Photo 18. Haul road for demolished buildings about 0.25 miles east of Fairview Rd. Note lack of erosion and sediment control BMPs, deep rills and sediment fans. Central Coast Water Board staff inspection photo.

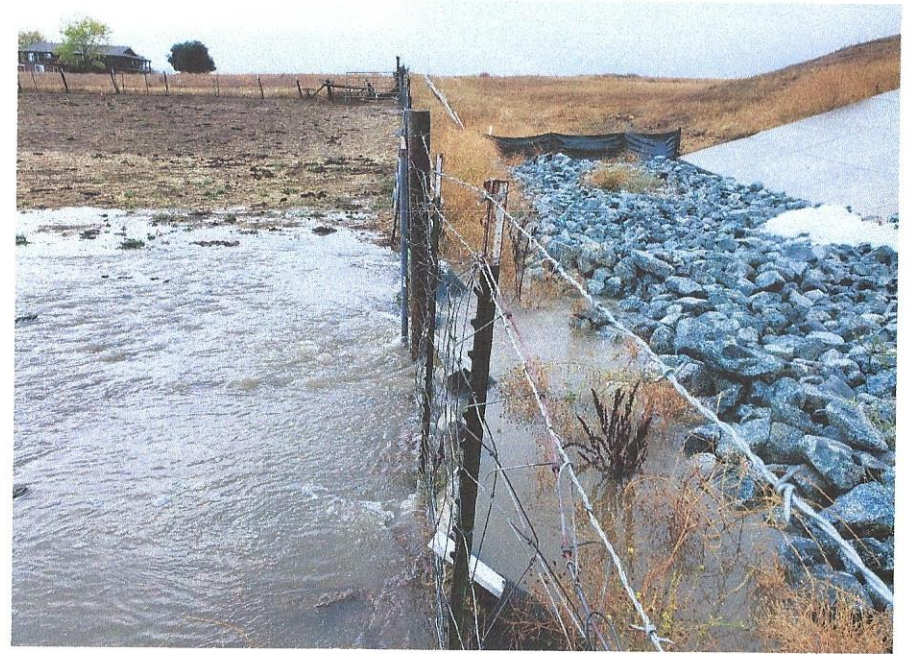
2
LOOKING NORTH FROM BASIN A

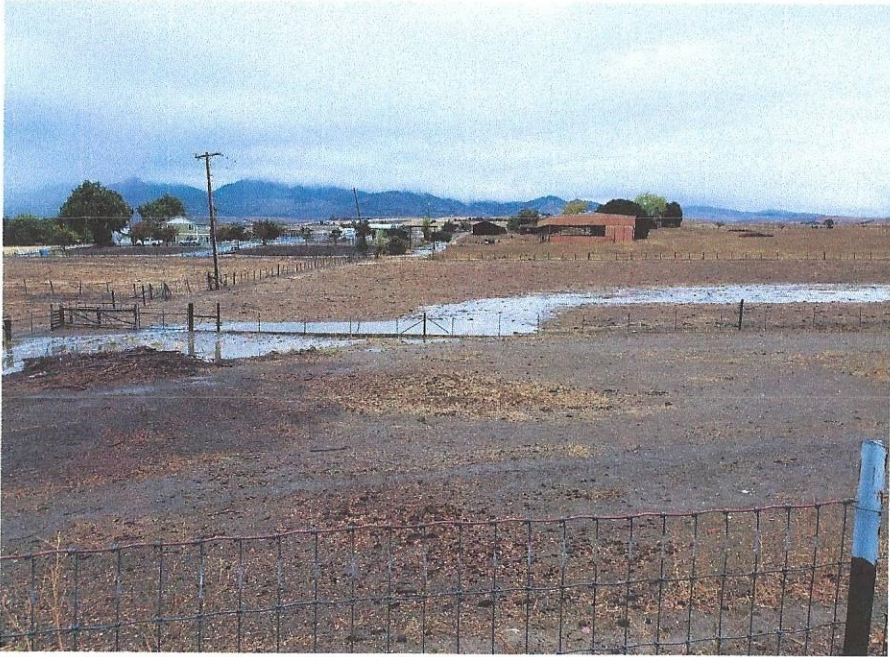
5

CROSSING CORNER (NE)

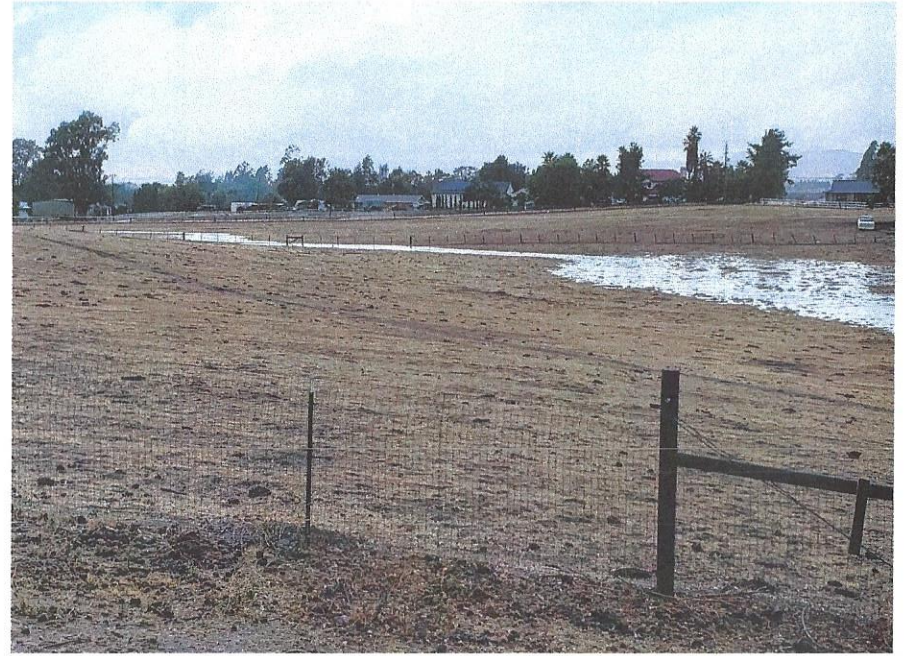
10

LOOKING SOUTH FROM MAUSFIELD RD.

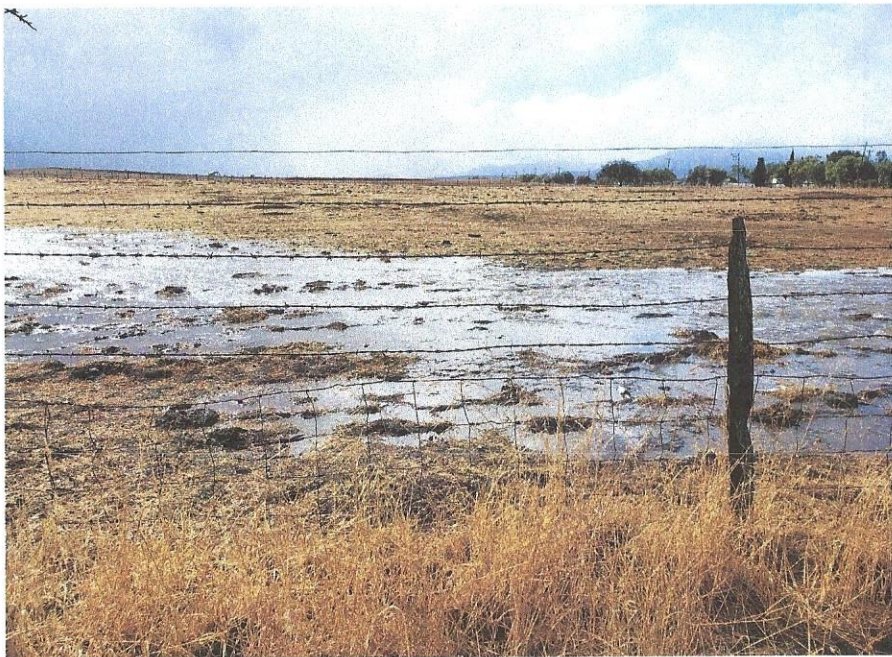
13

ALONG MANSFIELD RD SNYDER PROP.

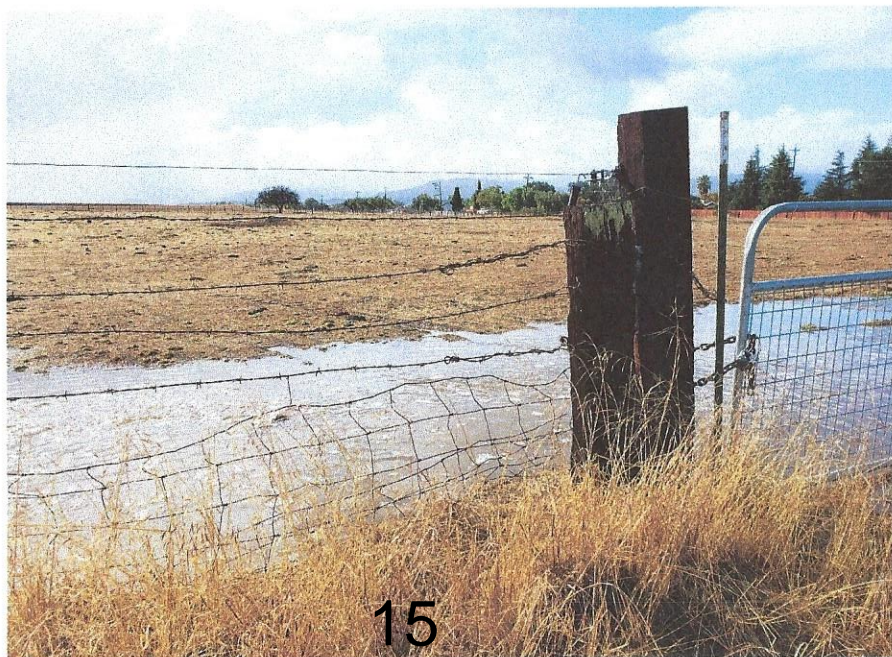
15

EDGE
GATE
GAS
LINE
