## Behavioral Health

San Benito County  
Facilities Master Plan

**Assessment Data Collection Worksheet**

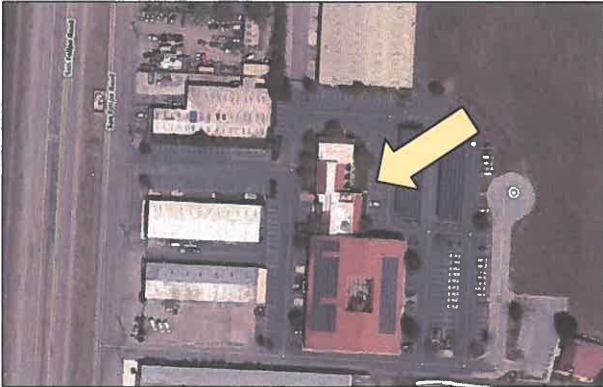
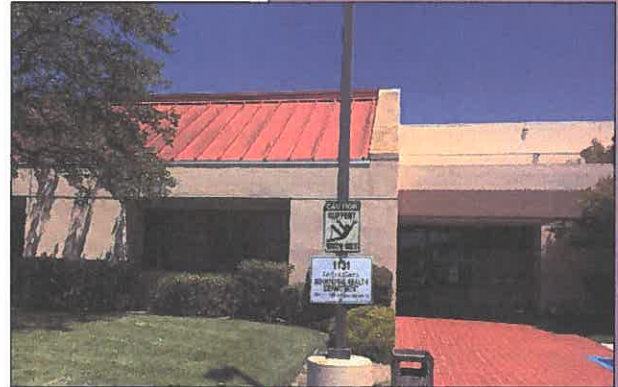
Address: 1131 San Felipe Road, Hollister  
Year Built: 1994+/-

No. of Stories: 1  
Square Feet: 12,000

**Facility Summary Observations:** Behavioral Health is currently housed in a leased facility adjacent and connected to HHSA. Behavioral Health is scheduled to move into a new facility in 2020-21. The facility is generally in fair condition.
